To:	Ray Senecal	From:	Jake Riley
	Kezar Lake Watershed Association		Topsham, Maine
File:	Stantec PN 195600843	Date:	December 19, 2013

Stantec Consulting Services Inc. (Stantec) and members of the Kezar Lake Watershed Association conducted a 2-day salmonid spawner and habitat survey in the Kezar Lake Watershed on November 13 and 22, 2013. This memorandum summarizes the results of the fall 2013 survey and serves to complete the 2013 scope of environmental services provided by Stantec for the Kezar Lake Watershed Association, Greater Lovell Land Trust, and FB Environmental.

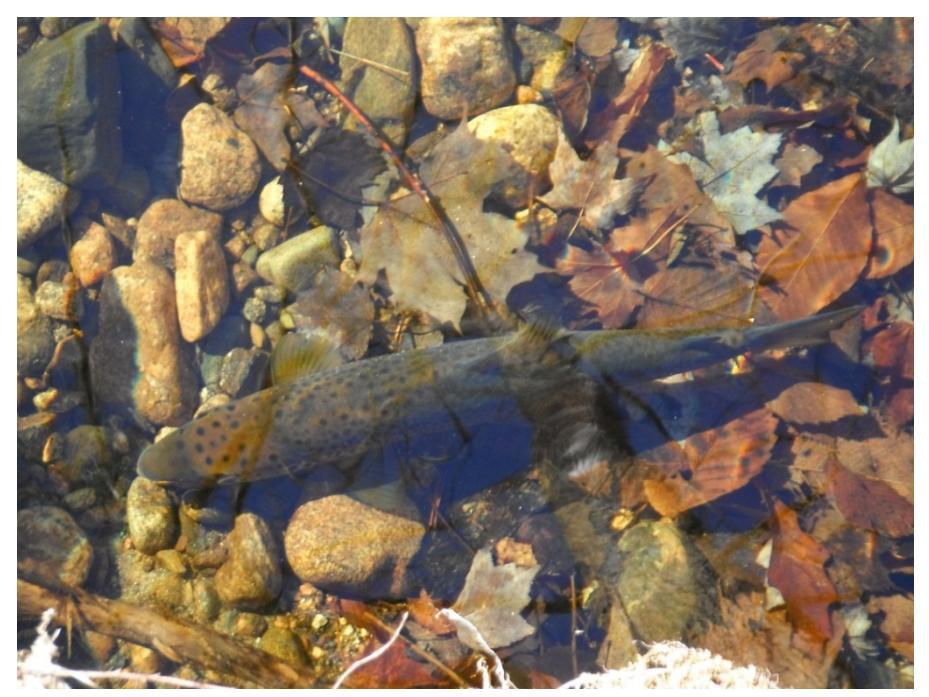
Photograph 1. Landlocked salmon in Great Brook downstream of the "first impediment".

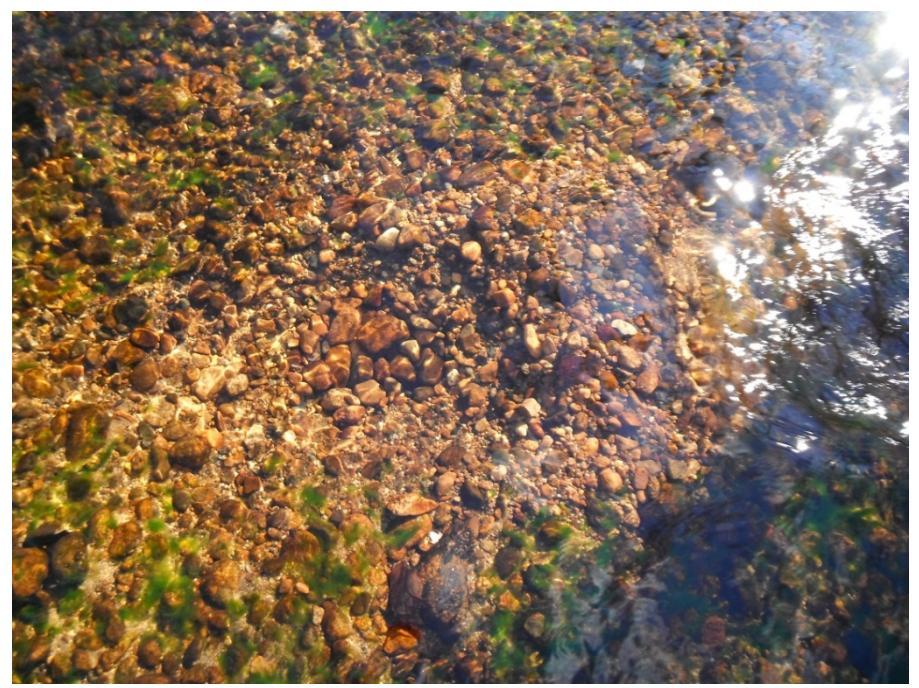
Photograph 2. Typical redd (GB-RD-1) size and shape of the pit and mound with a distinct margin of disturbed substrate in Great Brook.

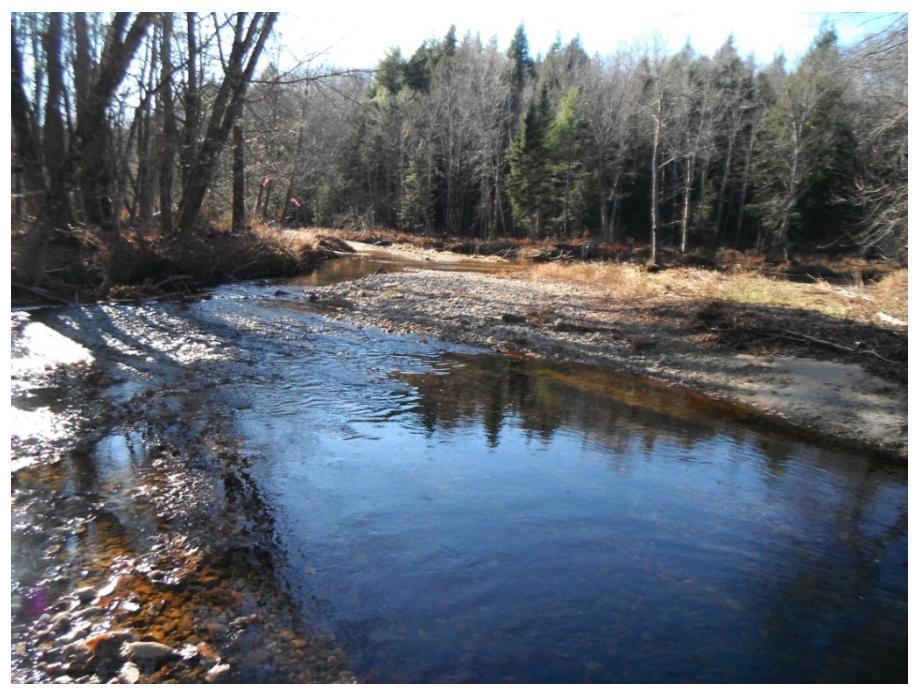
Approximately 1.85 river miles (RM) were surveyed from downstream of the Adams Road Bridge to Dwyer's Falls (see attached map). On November 13, the lower section of Great Brook was surveyed from downstream of Adams Road Bridge 0.74 miles upstream to the confluence with Beaver Brook. There were 36 redds, 10 adult landlocked salmon (Photograph 1) and 1 brook trout (7-9-inches) observed in the lower section of Great Brook, which had a higher density of redds per mile than the survey results from 2012 (Table 1). Given the large size of the redds and their proximity to adult live landlocked salmon, it is likely that all 32 redds were constructed by landlocked salmon. Downstream of the Adams Road bridge, there were only three redds in the pool/riffle areas compared to only one redd observed in last year's survey. In 2012, there were 6 redds between Adams Road and the "first impediment" compared to 29 redds observed in 2013. Thirteen of the 32 redds were located in the first run and head of a riffle downstream of the "first impediment" conceivably indicating that spawning salmon migrated as far as possible upstream before spawning. The clustering of redds abutting each other in large areas of disturbance downstream of the first impediment made it difficult to enumerate each individual redd objectively. Downstream of these 13 clustered redds, almost every pool tail or riffle head with suitable sized gravel had one or two redds (Photographs 2 and 3). The aquatic habitat in this section of Great Brook extending upstream of the Adams Road crossing to the Beaver Brook confluence is relatively sinuous and flat ($\sim 2\%$ gradient) as it flows through a wide floodplain. Lower Great Brook has high quality spawning habitat with deep pools, large woody debris cover, and successive riffle-pool-run habitat complexity with gravel dominated pool tails (Photograph 3).

Photograph 3. Successive pool tails with a total of three redds (GB-RD-17, 18 and 19) in Great Brook downstream of the "first impediment".

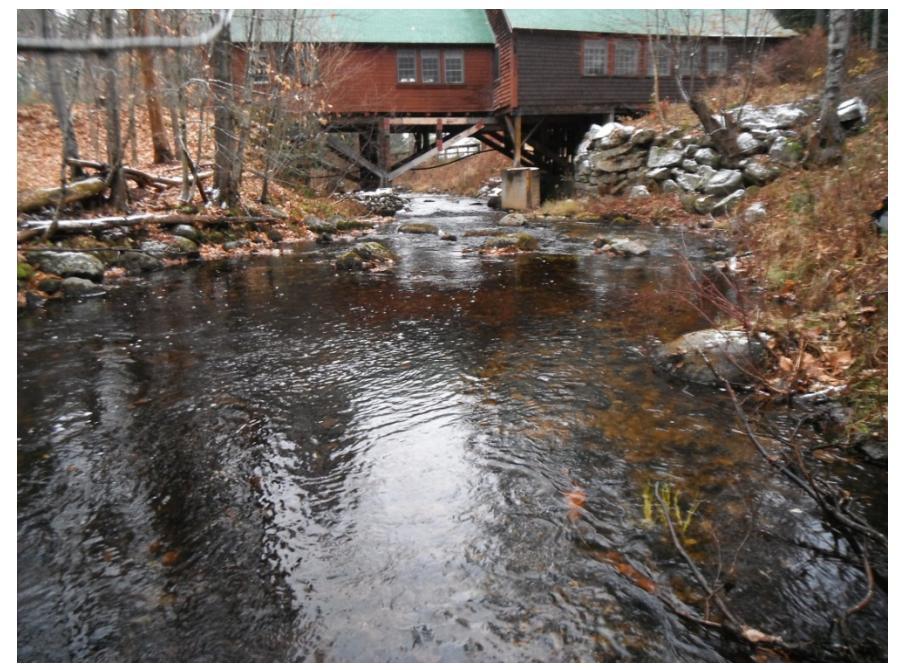
Photograph 4: Run with four successive redds (BB-RD-5 through BB-RD- 8) on the river right side of the channel.

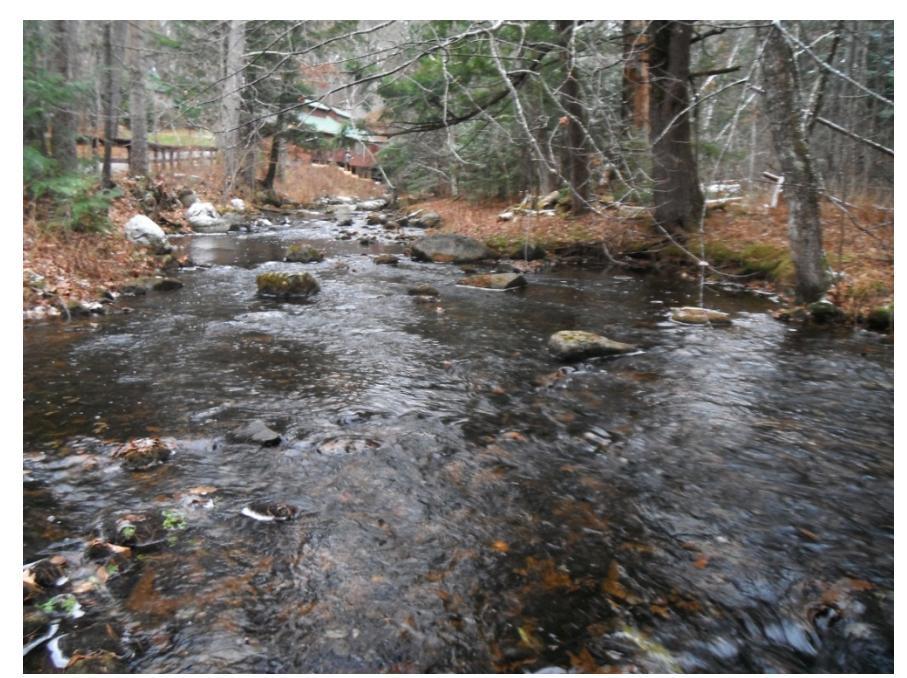
Between Kezar Lake and Route 5, Boulder Brook can be characterized as a moderately steep ($\sim 2\% - 3\%$ gradient), with few channel spanning pools and minimal large woody debris cover with larger substrate (e.g., cobbles and boulders) (Photograph 5). Despite anthropogenic development adjacent to the channel banks and/or within the floodplains in the lower portion of the area surveyed, Boulder Brook had stable banks with accessible bankfull small floodplains. There is a large plunge pool at the outlet of the culvert under Route 5 and the most upstream redd (BB-RD-17) was observed in the pool tail of the plunge pool. Upstream of the Route 5 culvert, the gradient of Boulder Brook flattened with no successive pool-riffle habitat. Approximately 1,000 feet upstream from the Route 5 culvert, there was channel spanning beaver dam creating a beaver pond within a meadow wetland complex as the channel dissipated into a lentic aquatic environment.

Photograph 5: Typical pocket-pool boulder habitat in Boulder Brook with minimal anthropogenic influences on the river right.

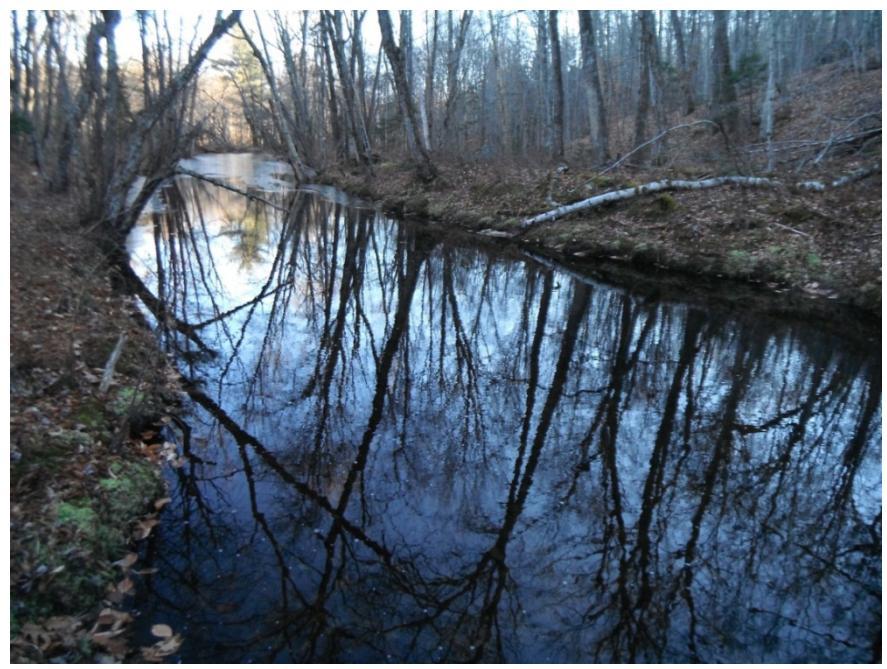
Photograph 6. Cold Brook is very flat with unsuitable spawning habitat adjacent to a wetland complex, near its confluence with Kezar Lake.

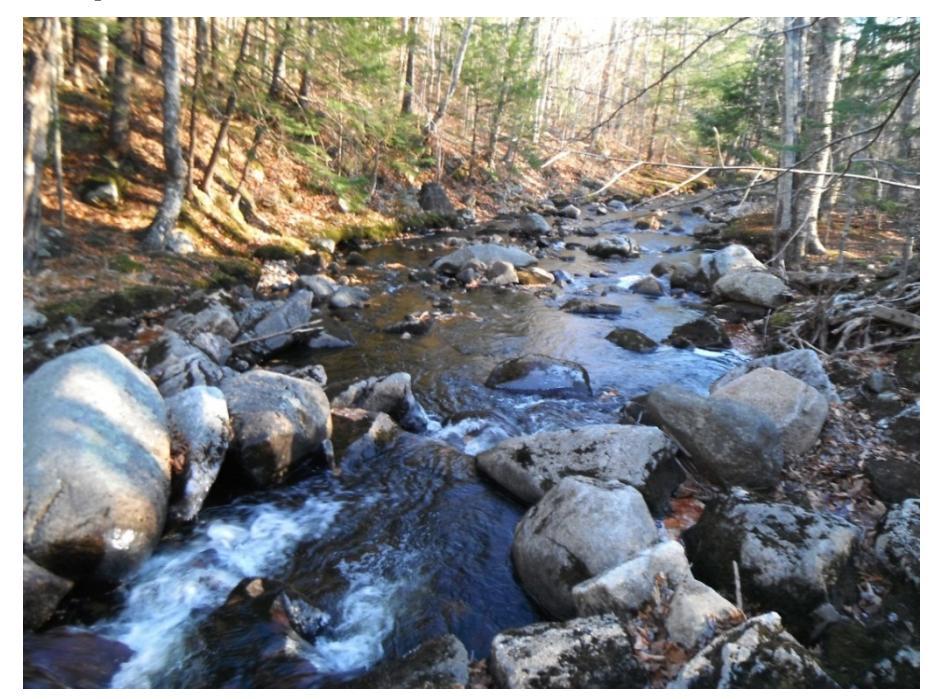
Photograph 7: Upper Cold Brook is steep and dominated by boulders with minimal pool development and suitable spawning substrate for landlocked salmon spawning.

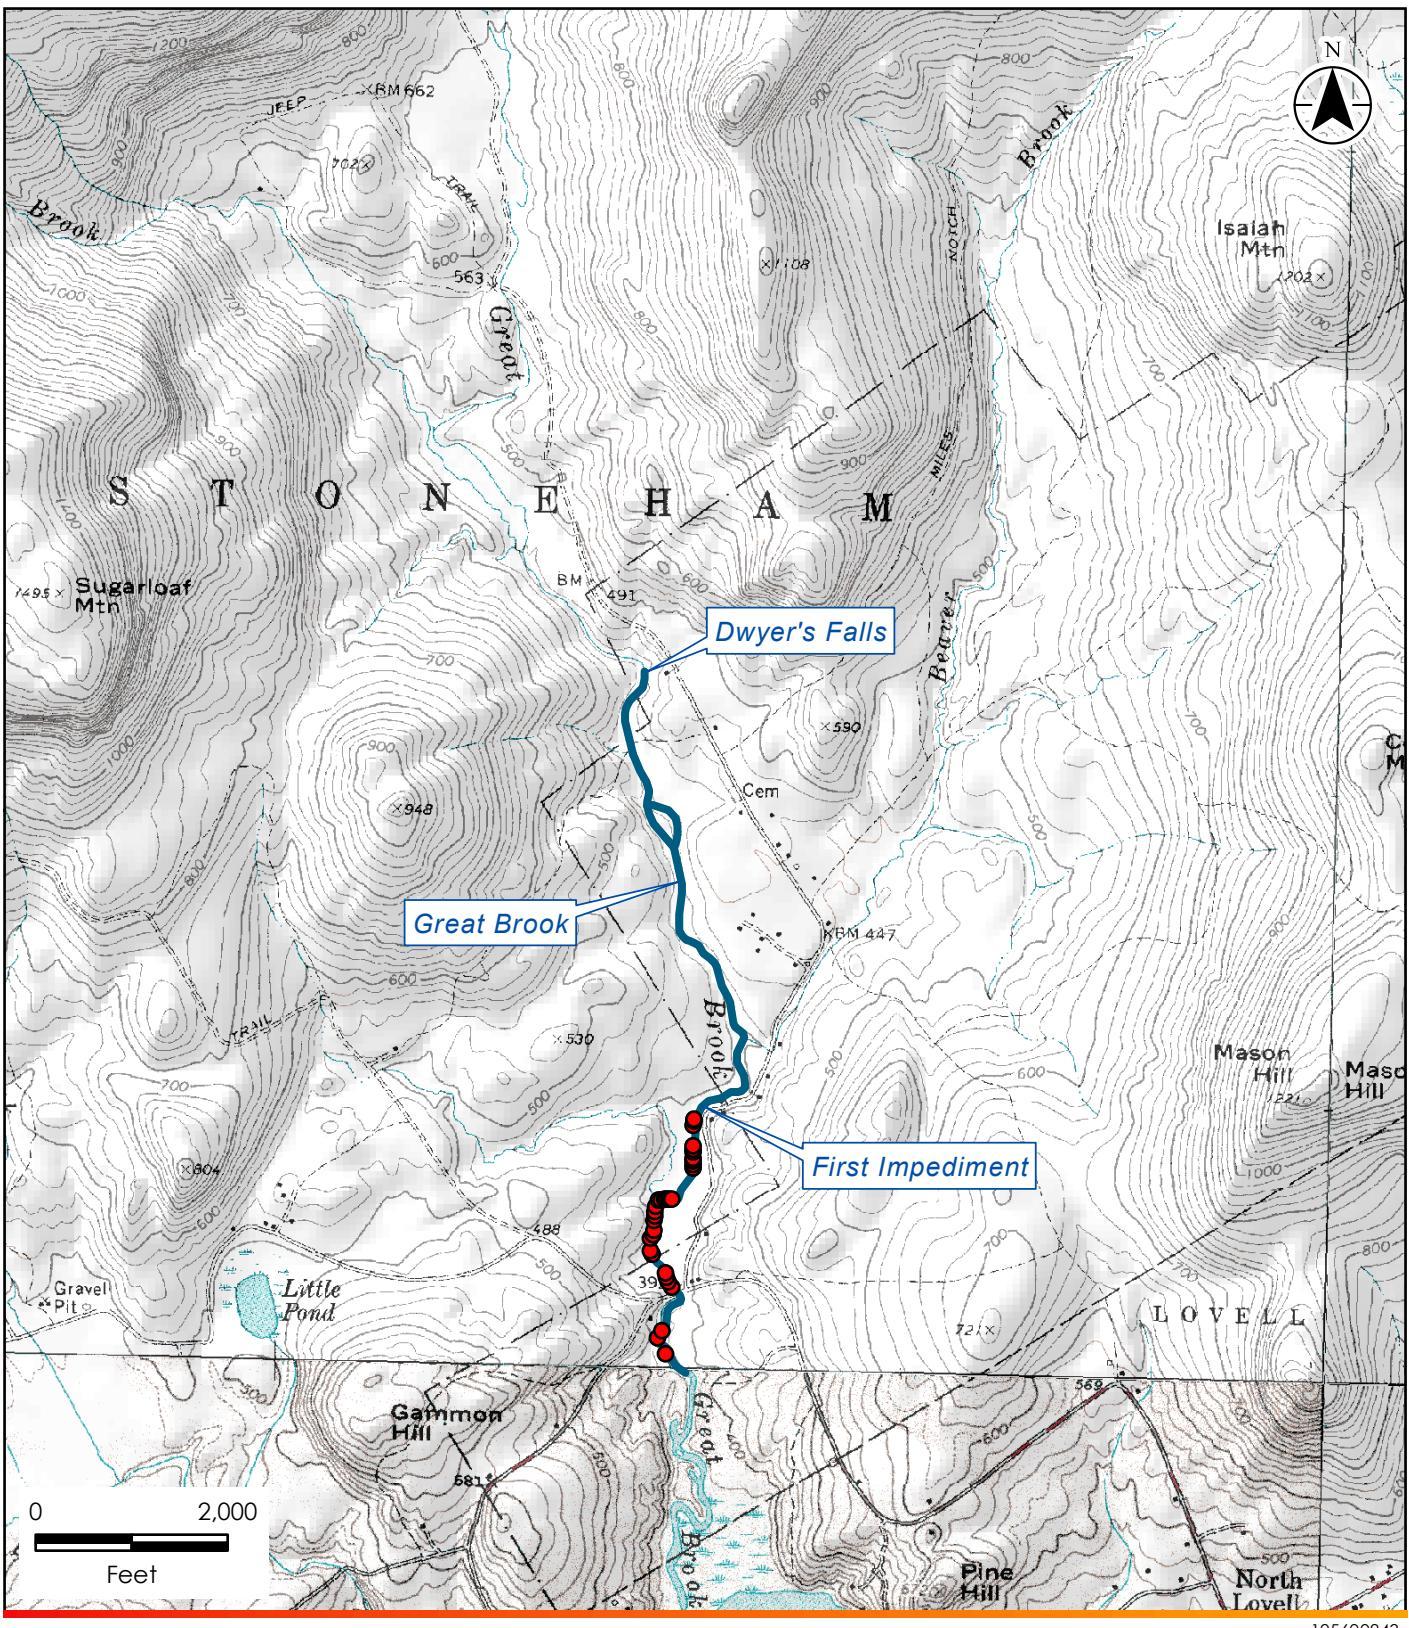
Title 2013 Great Brook Salmonid Spawn Survey 12/13/2013

• 32 Landlocked Salmon Redds Observed

Stream Segments Surveyed on 11/13/2013 & 11/22/2013 195600843

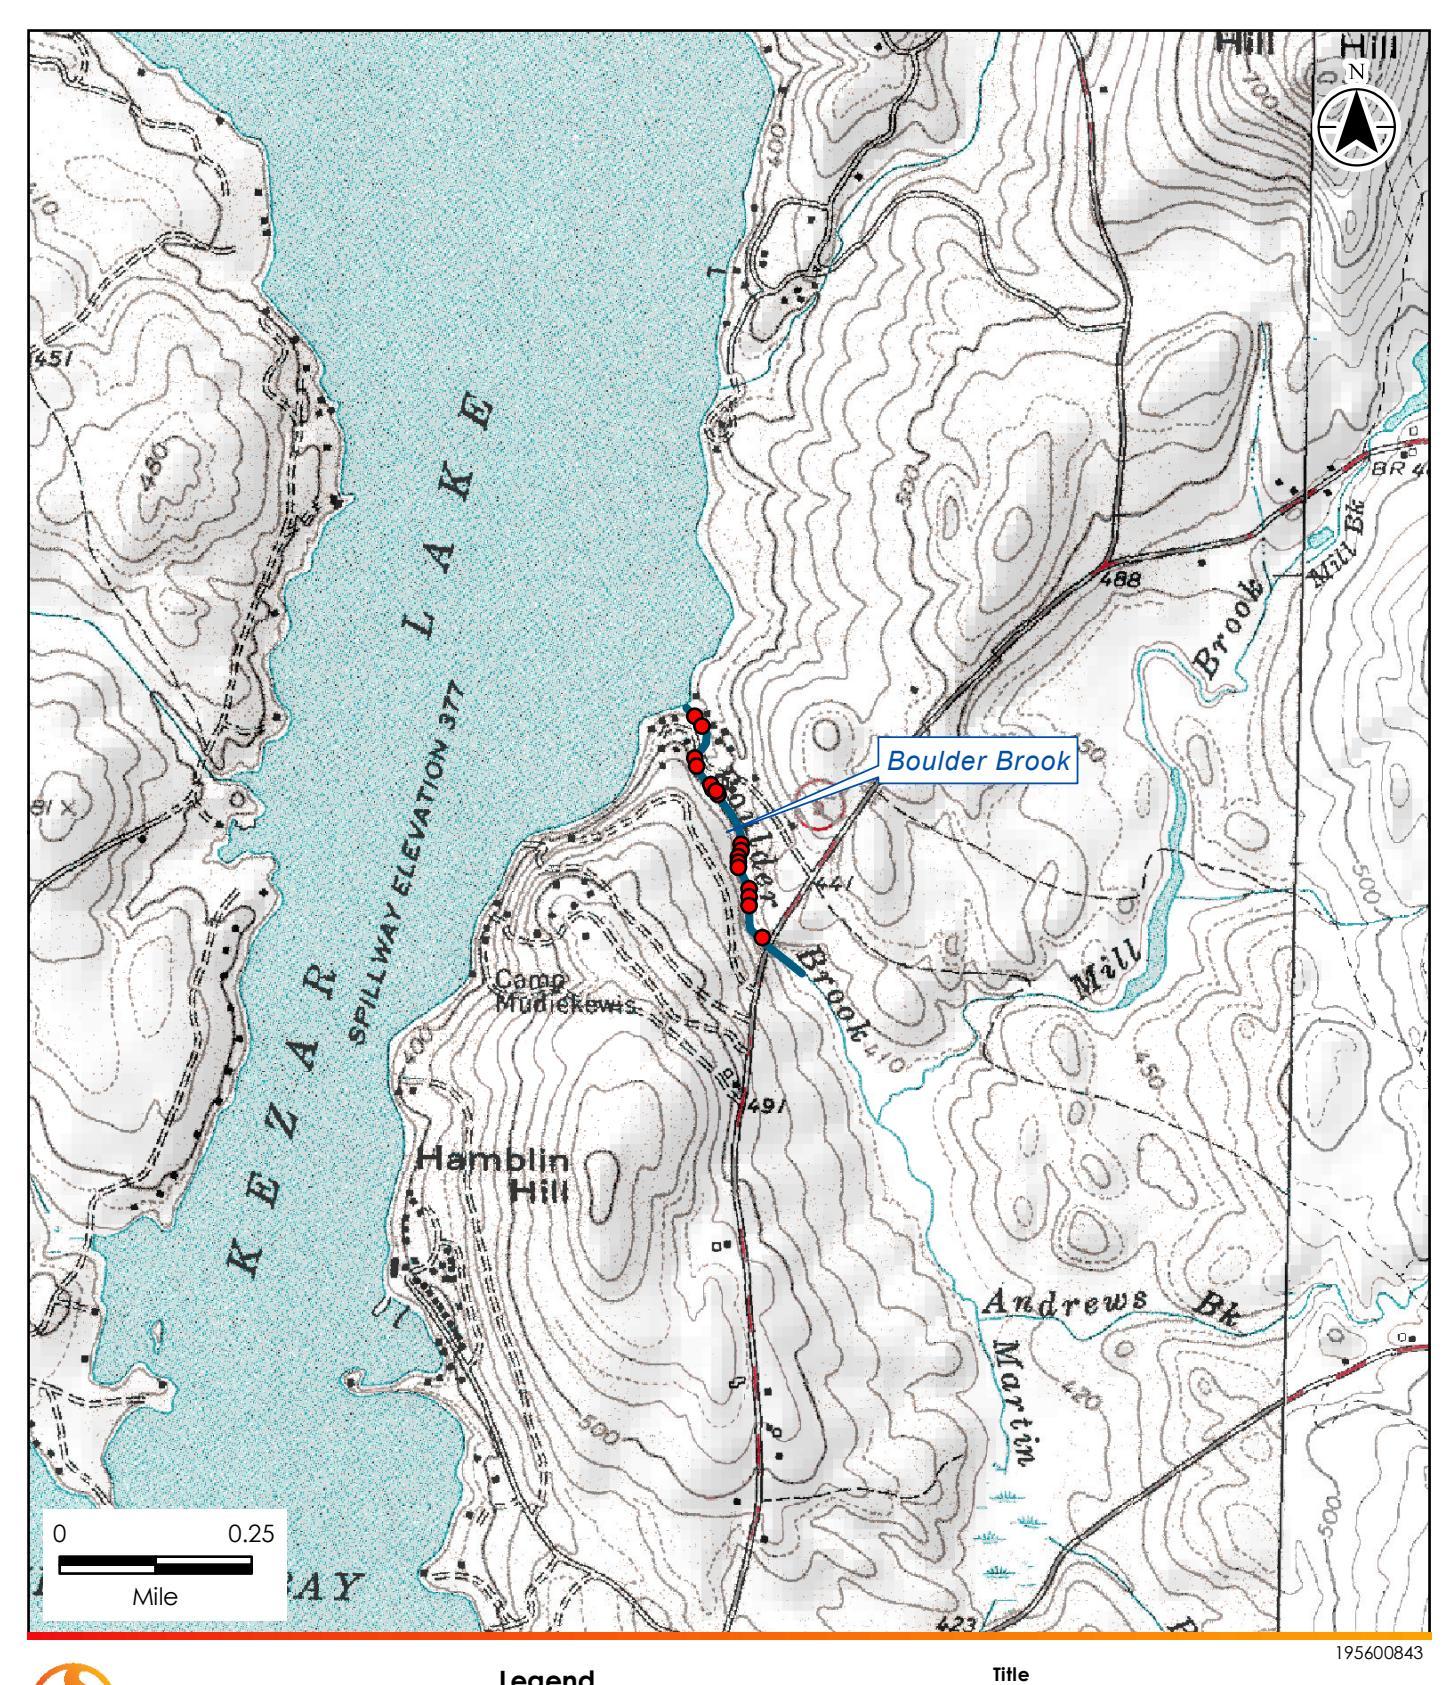
2013 Boulder Brook Salmonid Spawn Survey

On November 22, 2013, approximately 0.5 RM were surveyed in Boulder Brook upstream from its confluence with Kezar Lake to a beaver bog east of Route 5 (see attached map). Boulder Brook has a smaller watershed than Great Brook and the section surveyed does not contain as high quality salmonid spawning habitat (e.g., pools/riffles, large woody debris cover, and gravel substrate). Seventeen salmonid redds were observed between the confluence with Kezar Lake and the Route 5 crossing. The 44.7 redds per mile observed in Boulder Brook is very similar to density of redds in Great Brook in 2013 (Table 1). No spawning fish were observed in Boulder Brook during the survey, but it is likely that the redds were constructed by landlocked salmon based on their size and anecdotal information from representatives in the Kezar Lake Watershed Association. The redds were typically found in clusters in slower moving habitats with smaller spawning substrate (e.g., gravel). Four redds (BB-RD-5 through BB-RD- 8) were surveyed within a run 50 feet upstream of the recently rehabilitated small pier in Boulder Brook (Photograph 4). Landlocked salmon spawning activity was observed in this location in previous years (Ed Poliquin, personal communication).

- 17 Landlocked Salmon Redds Observed
- Stream Segments Surveyed on 11/22/2013

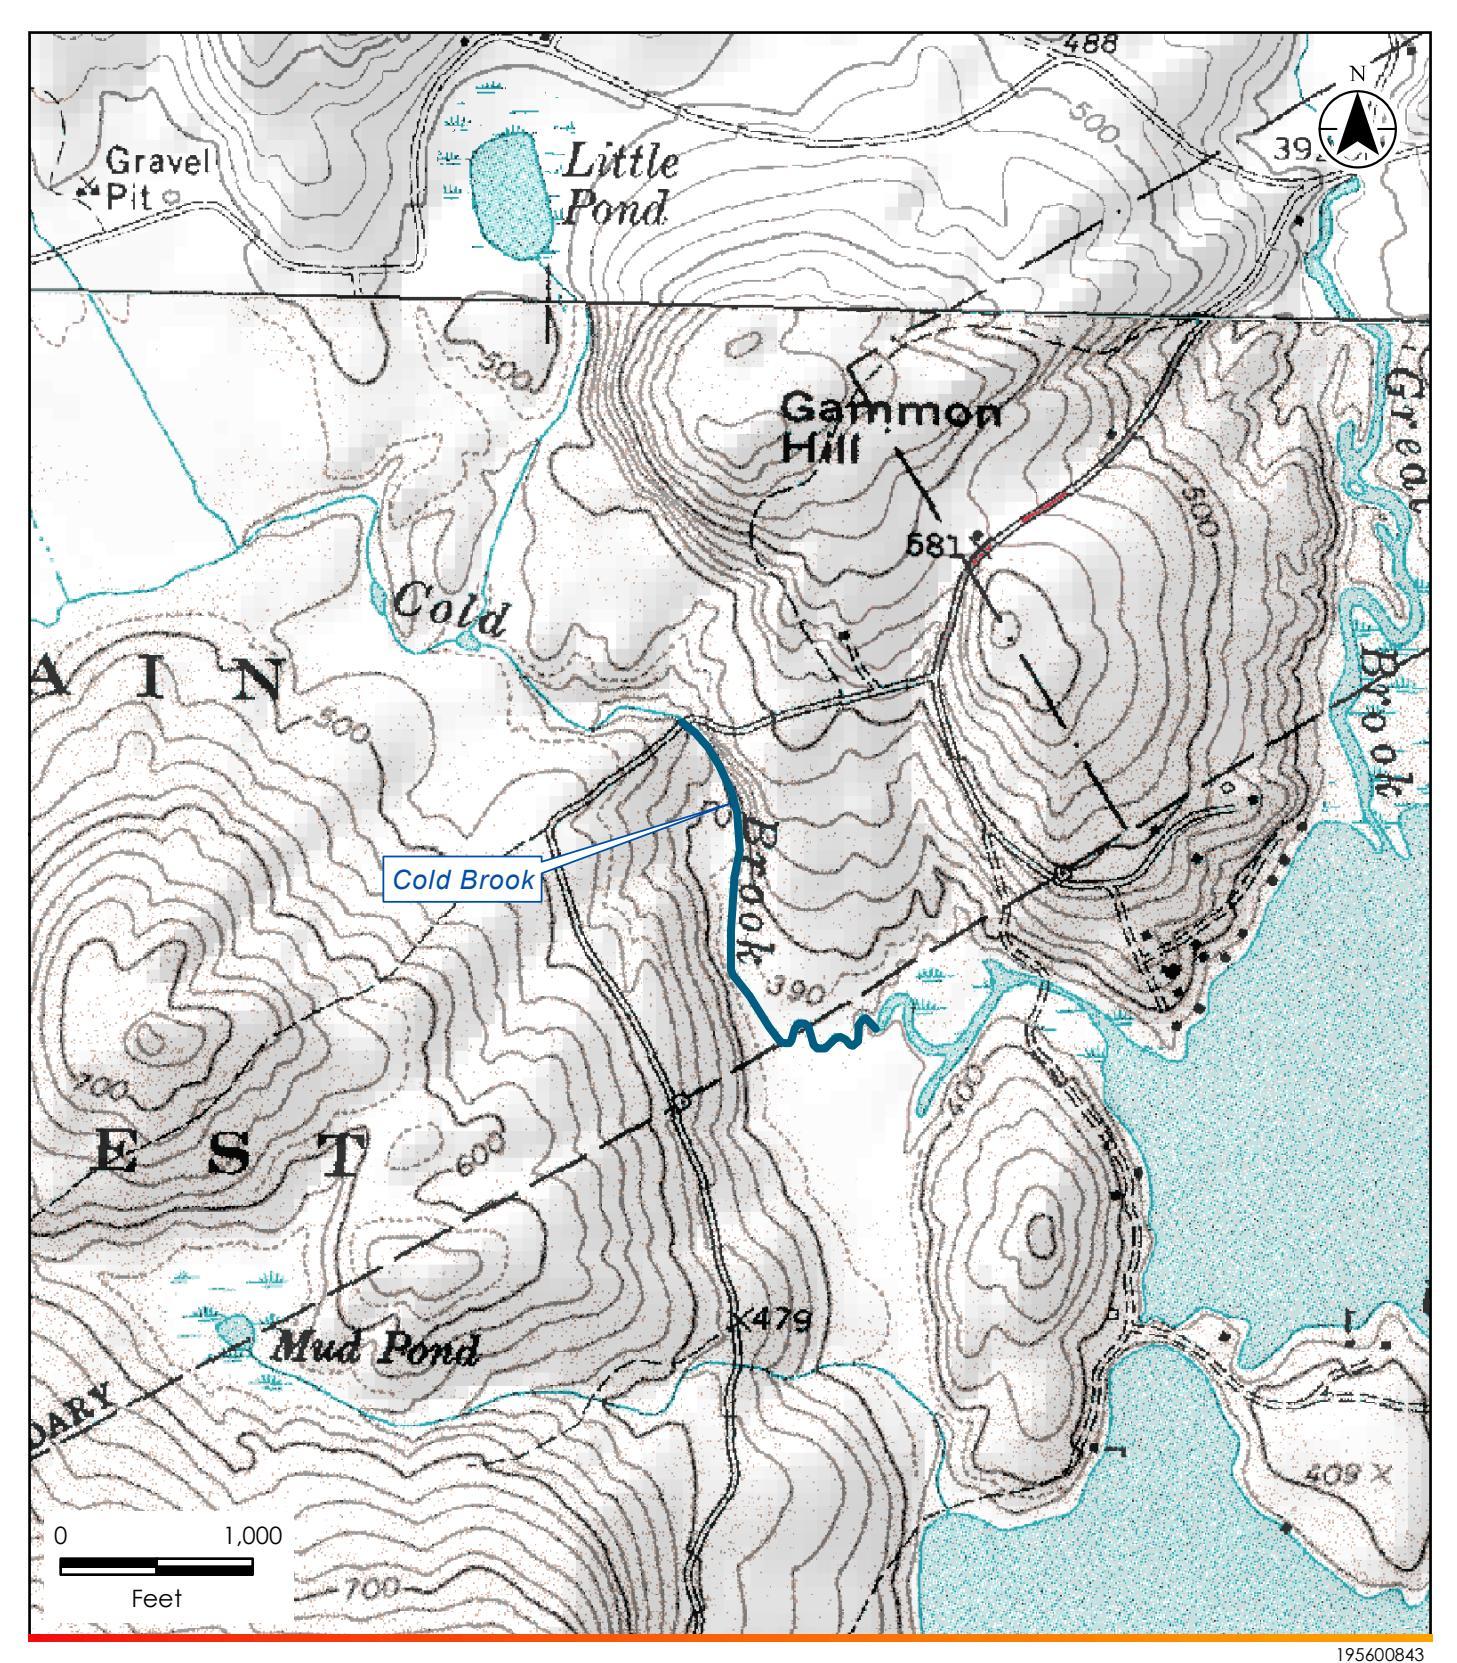
Title 2013 Cold Brook Salmonid Spawn Survey 12/13/2013

On November 13, 2013, approximately 0.45 RM were surveyed in Cold Brook from a wetland complex (near the confluence with Kezar Lake) to the culvert under Slide Hill Road (see attached map). No salmonids or redds were observed in the Cold Brook survey. The lower section of Cold Brook is very low gradient (<1% gradient) and can be characterized as poor spawning habitat with little observed suitable substrate or riffle/pool sequencing (Photograph 6). Between the much flatter section of Cold Brook and the Slide Hill Road culvert crossing, Cold Brook is a steep tributary (~4% – 6% gradient) dominated by larger substrate (cobble and boulders) (Photograph 7). Cold Brook has step/pool or cascade pocket pool stream morphology with very few developed pool tails—the microhabitat preferred by spawning landlocked salmon in Great Brook. Very little suitable spawning substrate was observed in Cold Brook. The section of Cold Brook surveyed appeared stable with no signs of erosion on the banks or fine sediment accumulated in the eddies. Approximately 500 feet downstream of the Slide Brook Road, there were multiple cascades (6 – 9 feet high), which are impediments to upstream passage by fish moving up out of Kezar Lake. These bedrock steep features are likely acting as migration barriers to smallmouth bass and other non-native fish species in Kezar Lake, thus maintaining up upper portions of Cold Brook for resident native brook trout. Upstream of the impediments and Slide Hill Road, Cold Brook had what appeared to be quality small mountain stream brook trout habitat.

- 0 Landlocked Salmon Redds Observed
- Stream Segments Surveyed on 11/13/2013
